# 4-Point Inspection Form

Address Inspected: 4102 N 48th Terrace #7-25, Hollywood, FL 33021

Actual Year Built: 1977 Date Inspected: 02/14/2023

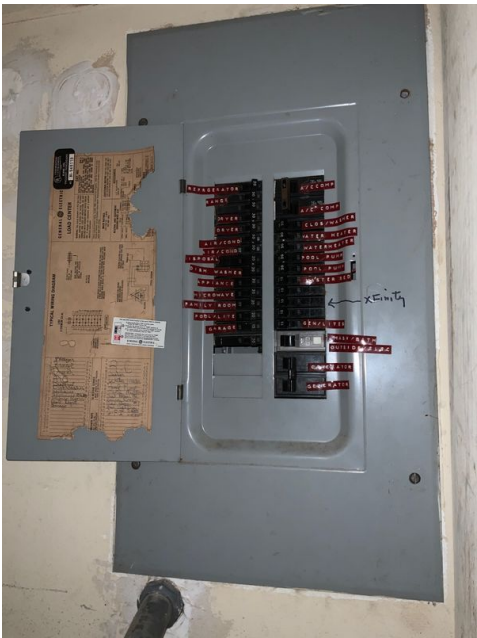
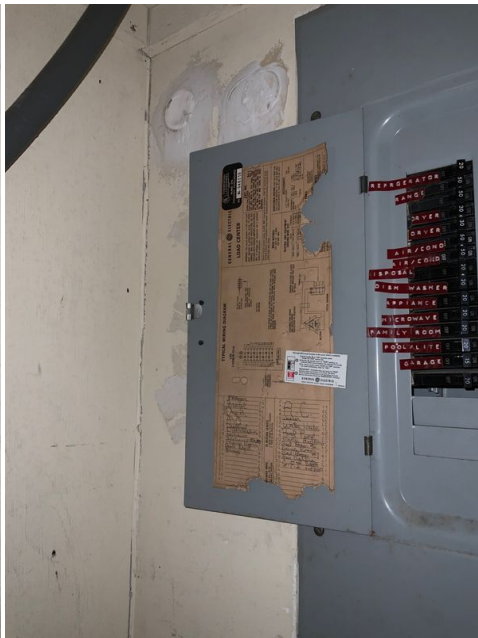
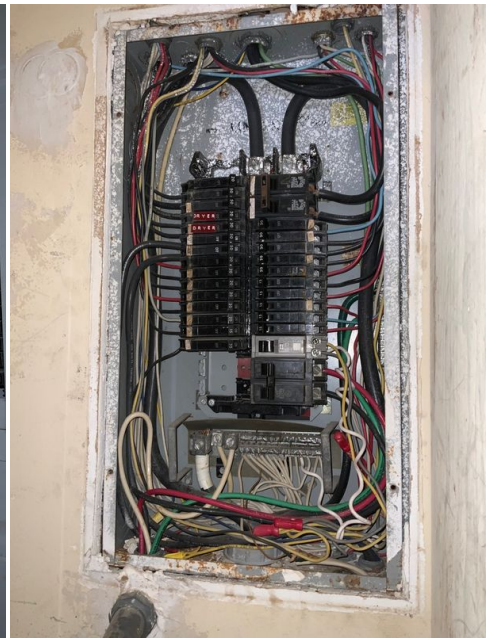
### Panel Photos

General condition of the electrical system: ☒ Satisfactory ☐ Unsatisfactory (explain)

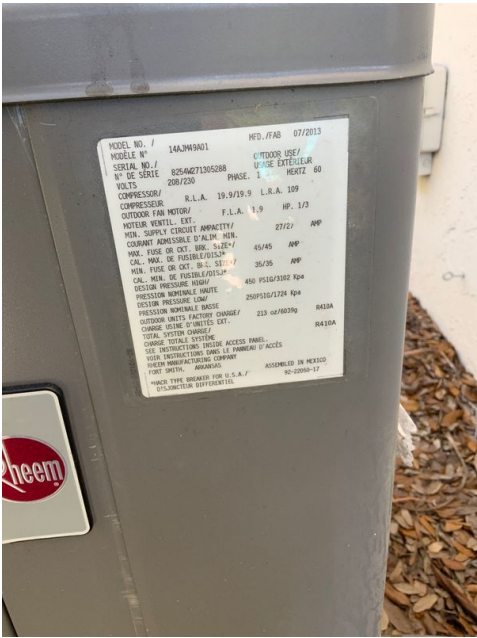
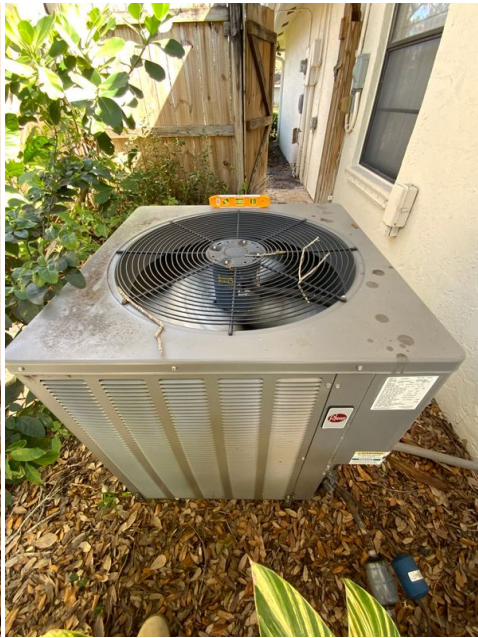
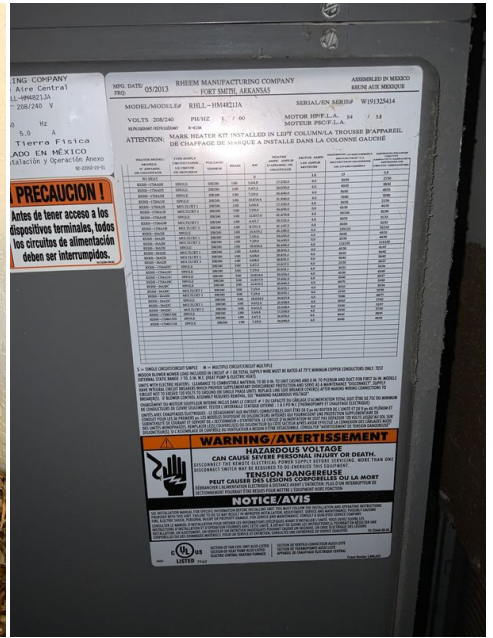
HVAC Equipment

Are the heating, ventilation and air conditioning systems in good working order? ☒ Yes ☐ No (explain)

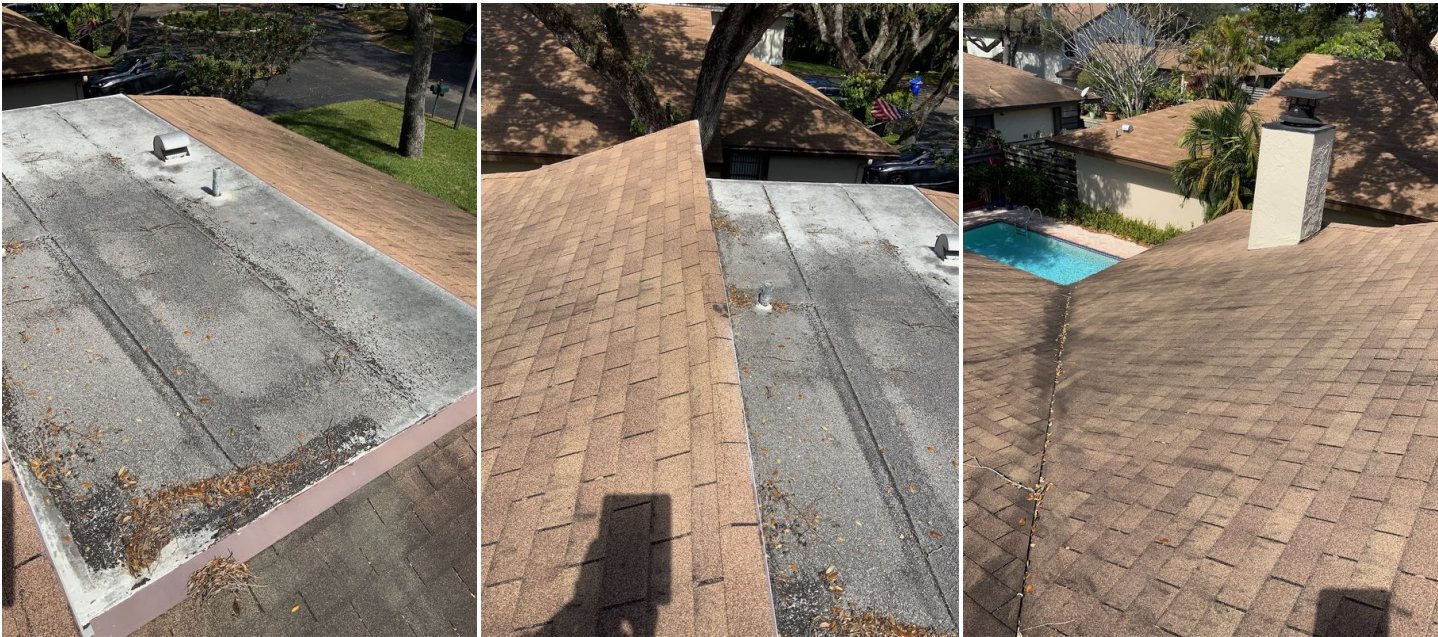
Photos of Each Slope

☒ Satisfactory
